## Comparative Fatigue Failure Analysis of Axle Shafts in Two Front Wheel Drive Vehicles

Emin Çengelci<sup>1</sup>✉, Arif Hakan Yalçın<sup>2</sup>, Ercan Şimşir<sup>3</sup>, Murat Baraz<sup>4</sup>, İbrahim Yavuz<sup>3</sup><sup>1</sup>Iscehisar Vocational School Motor Vehicles and Transportation Technologies Department, Afyon Kocatepe University, Afyonkarahisar, Türkiye<sup>2</sup>Sultandagi Vocational School Transportation Services Department, Afyon Kocatepe University, Afyonkarahisar, Türkiye<sup>3</sup>Afyon Kocatepe University, Faculty of Technology Automotive Engineering, Afyonkarahisar, Türkiye<sup>4</sup>Bolvadin Vocational School Electricity and Energy Department, Afyon Kocatepe University, Afyonkarahisar, Türkiye

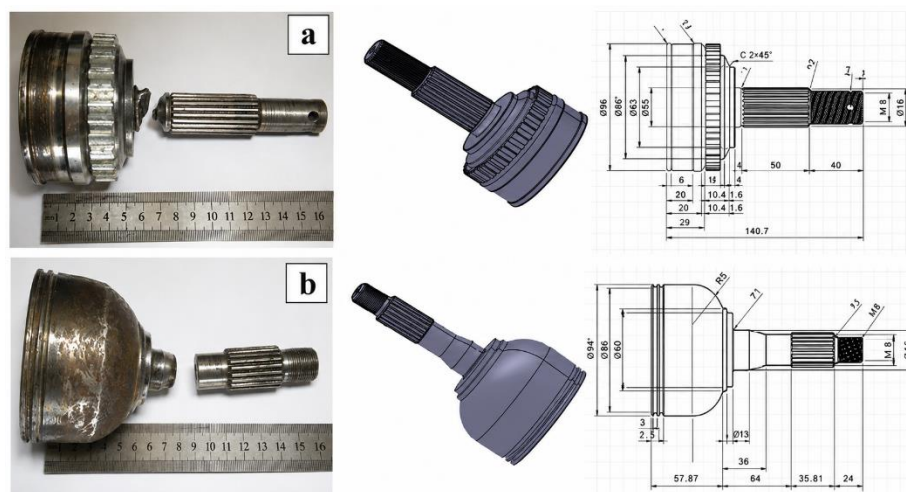
Figure 2. Solid models and dimensioned schematic representations of damaged axle shafts: (a) Vehicle 1, (b) Vehicle 2

Figure 2 shows a comparative presentation of damaged samples of the axle shafts of Vehicle 1 and Vehicle 2, along with solid models and dimensioned technical drawings created in SolidWorks. The axle shaft of Vehicle 1, shown in Figure 2a, has a total length of approximately 149 mm, and a significant fracture (breakage) is observed at the point where the shaft joins the housing in the physical sample. The length of the milled (toothed) section in the technical drawing of this shaft is measured as 50 mm. The solid model-ing shows that the complex geometry and

The axle shaft of Vehicle 2, shown in Figure 2b, exhibits structural differences compared to Vehicle 1, particularly noting that the outer housing has a more convex geometry. Similarly, a damage condition where the shaft separates from the housing is observed in this sample as well. The length of the milled (toothed) section in the technical drawing is given as approximately 36 mm, and the axle shaft has a total length of approximately 174 mm.

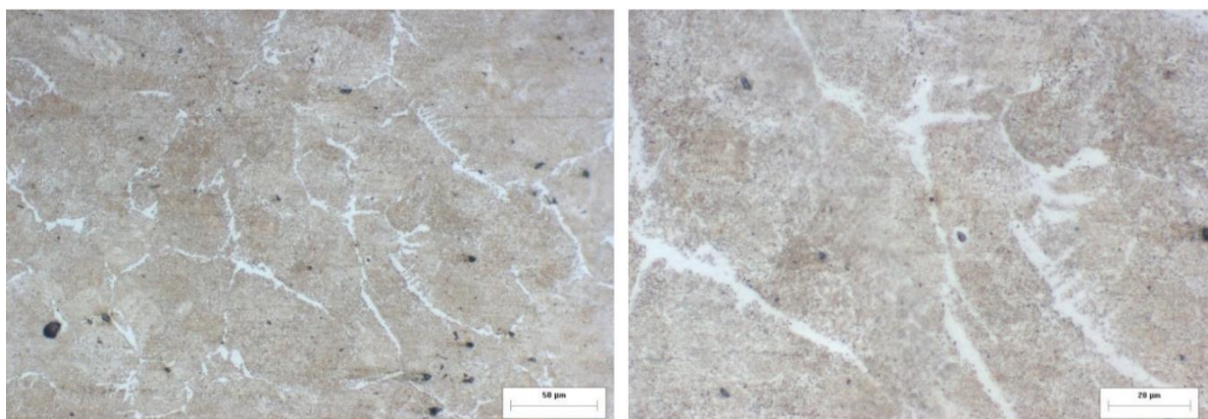
**Figure 3.** Micro structure of vehicle 1 axle shaft

As seen in [Figure 3](#), a microstructure is observed in the sample from Vehicle 1 where cementite phases are embedded in a network structure within the ferrite matrix. This

microstructural appearance suggests that the cementite phase may not be fully spheroidized and retains a reticular morphology in some regions. Such carbide distributions can be considered as microstructural discontinuities that may create favorable regions for crack propagation along grain boundaries. However, since records of the heat treatment history applied to the samples are not available, it cannot be definitively stated that the observed structure resulted directly from incomplete spheroidization annealing.

While this type of microstructure exhibits relatively high hardness values, it may show poor performance in terms of crack resistance and impact toughness. Although no significant decarburization traces are observed on the surface, the discontinuous distribution of cementite in the network structure suggests that the homogeneity of the heat treatment is limited. However, the spherical and homogeneous distribution of the carbide phase within the ferrite matrix is a characteristic result of a successful spherization annealing process applied for a long period at approximately 700–720 °C.

Furthermore, micro-voids and inclusion-like structures observed within the matrix cause stress concentrations, creating crack initiation points. These microstructural weaknesses, combined with the notch effect observed in the axle shaft, lead to preferential crack propagation along grain boundaries under fatigue loads, resulting in earlier fatigue fracture.

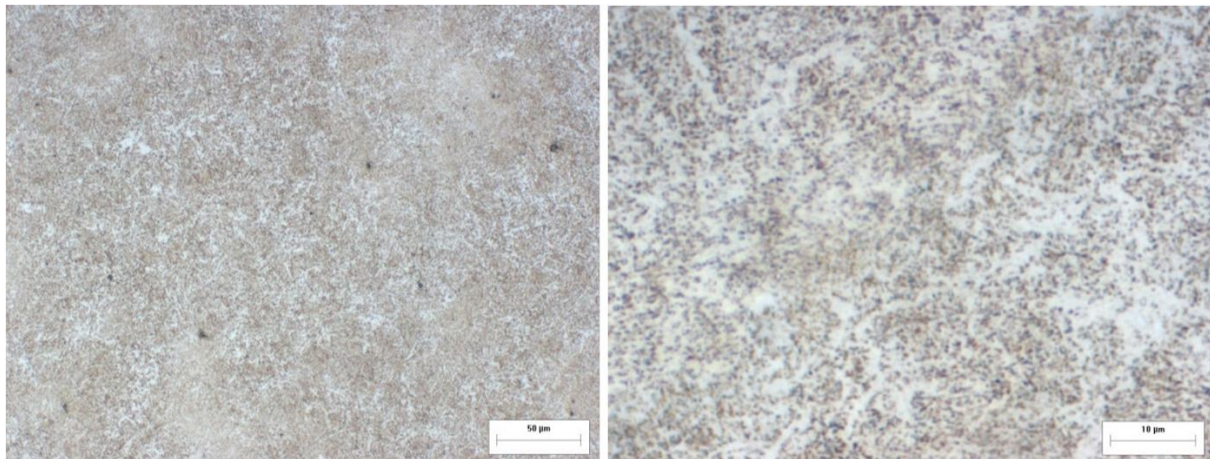
**Figure 4.** Micro structure of vehicle 2 axle shaft

[Figure 4](#) presents optical microstructure images of a sample taken from the axle shaft of Vehicle 2 at different magnifications (50 µm and 10 µm). The microstructure generally exhibits a ferrite-

pearlite-based matrix structure, with widespread and relatively homogeneously distributed fine carbide phases within the matrix. However, discontinuous white network-like phase separations along the grain boundaries and scattered micro-voids and inclusion-like structures have also been detected in some regions. These regions cause stress concentration, creating potential weak areas in terms of fatigue crack initiation and propagation paths.

No significant decarburization effect is observed on the surface, and the structure generally exhibits a more homogeneous distribution compared to Vehicle 1. The finer and more dispersed carbide morphology may allow for greater energy absorption before deformation, supporting a relatively more ductile fracture behavior. However, discontinuous phase separations and micro-defects observed along the grain boundaries may have facilitated microcrack formation in subsequent load cycles, contributing to eventual fatigue fracture [38].

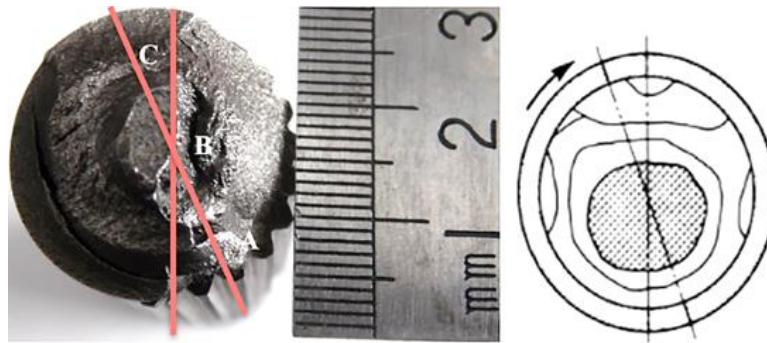
**Figure 5.** Areas where SEM images were taken by Vehicle 1

When the fracture surface morphology of the axle shaft of Vehicle 1 is evaluated, it is observed that the crack initiation occurs from the surface and possibly from a stress concentration zone, while the fatigue traces progress regularly and concentrically along the cross-section. These observations suggest that the fracture developed under a fatigue-related mechanism, with crack propagation features consistent with cyclic loading conditions. However, due to the absence of direct stress calculations, service load history, and fatigue striation measurements, the specific stress level and loading mode cannot be

confirmed. After the fatigue crack reduced the cross-sectional area to a critical level, the remaining section ruptured with a sudden and brittle fast fracture, and the fracture surface characteristics show similarities with fatigue fracture features reported in the literature; however, the exact loading condition and stress amplitude cannot be determined without additional mechanical data.

To support these macroscopic findings, microstructural examination was performed by taking SEM images from three different regions of the analyzed axle shaft. These regions are shown in Figure 5 for Vehicle 1. In the SEM images, fracture orientations parallel to the direction of the torsional force and traces of plastic deformation in places were observed, and macro-crack regions, which were assessed to be related to sudden loading, were examined in detail. When the fracture characteristics of the material were evaluated, brittle fracture features were detected in some regions, while microstructural deformation traces indicating ductile fracture were detected in other regions.

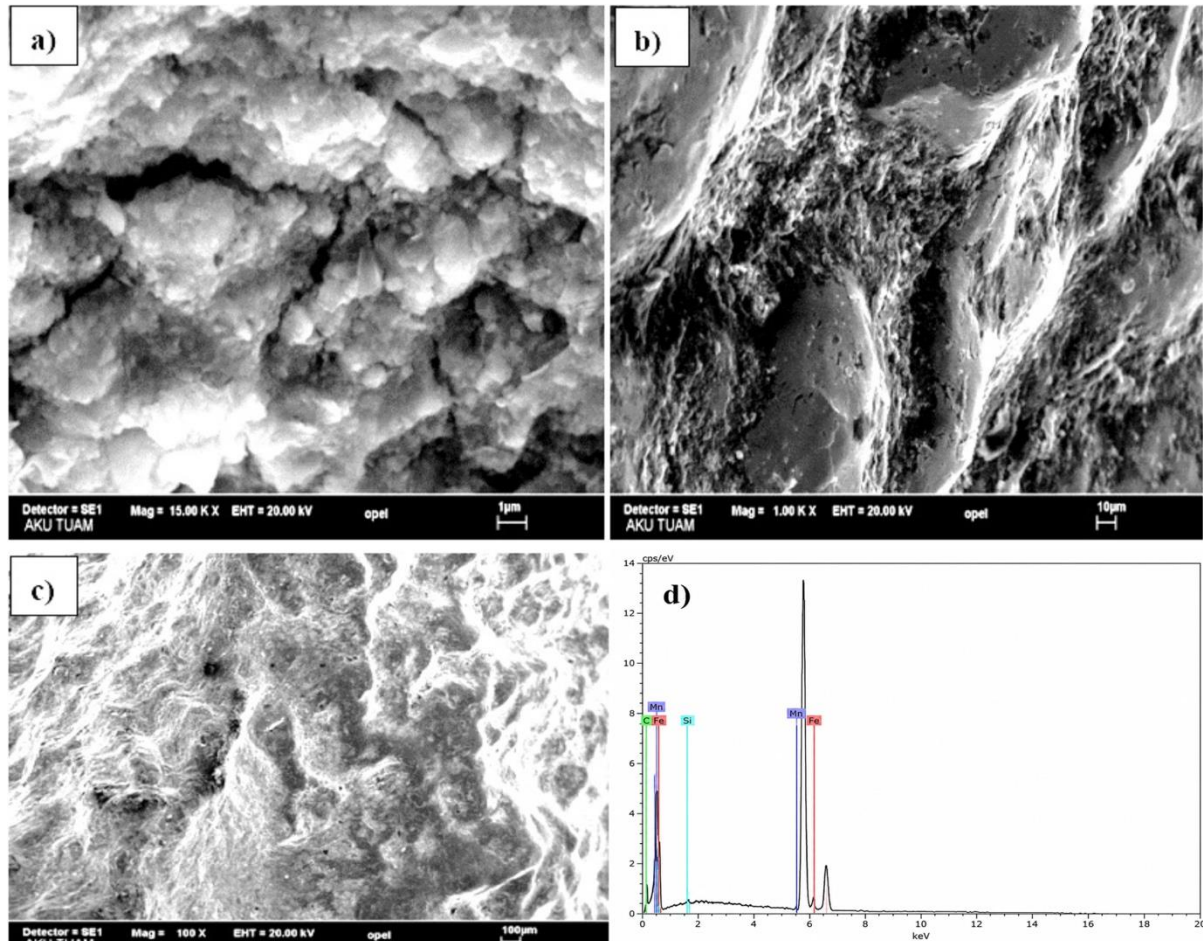
**Figure 6.** SEM and EDX images of Vehicle 1 fracture surface showing crack initiation region, fatigue crack propagation area, and final fracture region

SEM images obtained from different regions of the fractured axle shaft are presented in Figure 6. The macroscopic and scanning electron microscopy (SEM) images of the fracture surfaces of Vehicle 1 and Vehicle 2 reveal significant differences in terms of the fracture mechanisms of the materials. In the macroscopic image of Vehicle 1, the fracture surface is observed to be quite rough, bearing distinct crack traces, and the cracks mostly propagate in a planar manner. Such fracture surfaces indicate a tendency towards brittle fracture under sudden loading. In the SEM images shown in Figure 6a to Figure 6c the regions

corresponding to crack initiation and propagation exhibit relatively flat fracture features with limited plastic deformation, whereas the final fracture region displays different fracture characteristics. In particular, image [Figure 6a](#) shows numerous small, massive fracture surface crystals, which indicates a typical brittle fracture morphology progressing along a grain boundary. In images [Figure 6b](#) and [Figure 6c](#), the crack propagates abruptly, with minimal traces of plastic deformation and predominantly flat

surfaces devoid of fibrous structure. Image [Figure 6d](#) is the EDX image of Vehicle 1. These micromorphological features clearly demonstrate that the cementite phases in the network structure present in the microstructure of the sample belonging to vehicle 1 caused crack propagation, and therefore the fracture is brittle.

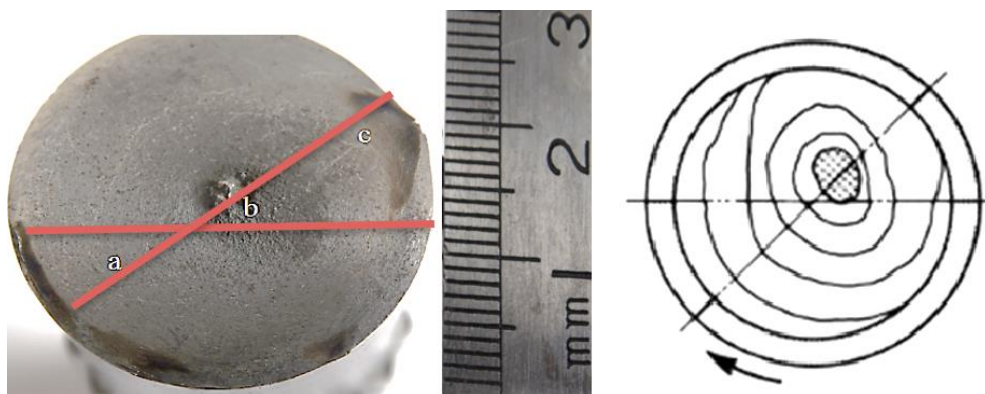
**Figure 7.** Areas where SEM images were taken by Vehicle 2

The fracture surfaces of Vehicle 2 exhibit different fracture behavior compared to Vehicle 1, both macroscopically and microscopically. [Figure 7](#) shows the regions where SEM images were

taken for Vehicle 2. In the macroscopic examination, asymmetric and spiral fatigue propagation traces are noticeable on the fracture surface. When the fracture surface morphology of the Vehicle 2 axle shaft is evaluated, it is assessed that the crack initiation occurred from the surface and from a possible stress concentration region, but the irregular and spiral propagation of the fatigue traces indicates that the fracture developed mainly under rotating bending fatigue, in addition to significant torsional components, and therefore the effective stress amplitude is higher.

Under these conditions, the propagation rate of the fatigue crack increased, the cross-sectional area reached the critical level in a shorter time, and the fracture resulted in a fast fracture region with a sudden and brittle character in the center. The fracture surface patterns exhibit characteristics consistent with rotational fatigue fractures under high stress levels and combined bending-torsion effects reported in the literature.

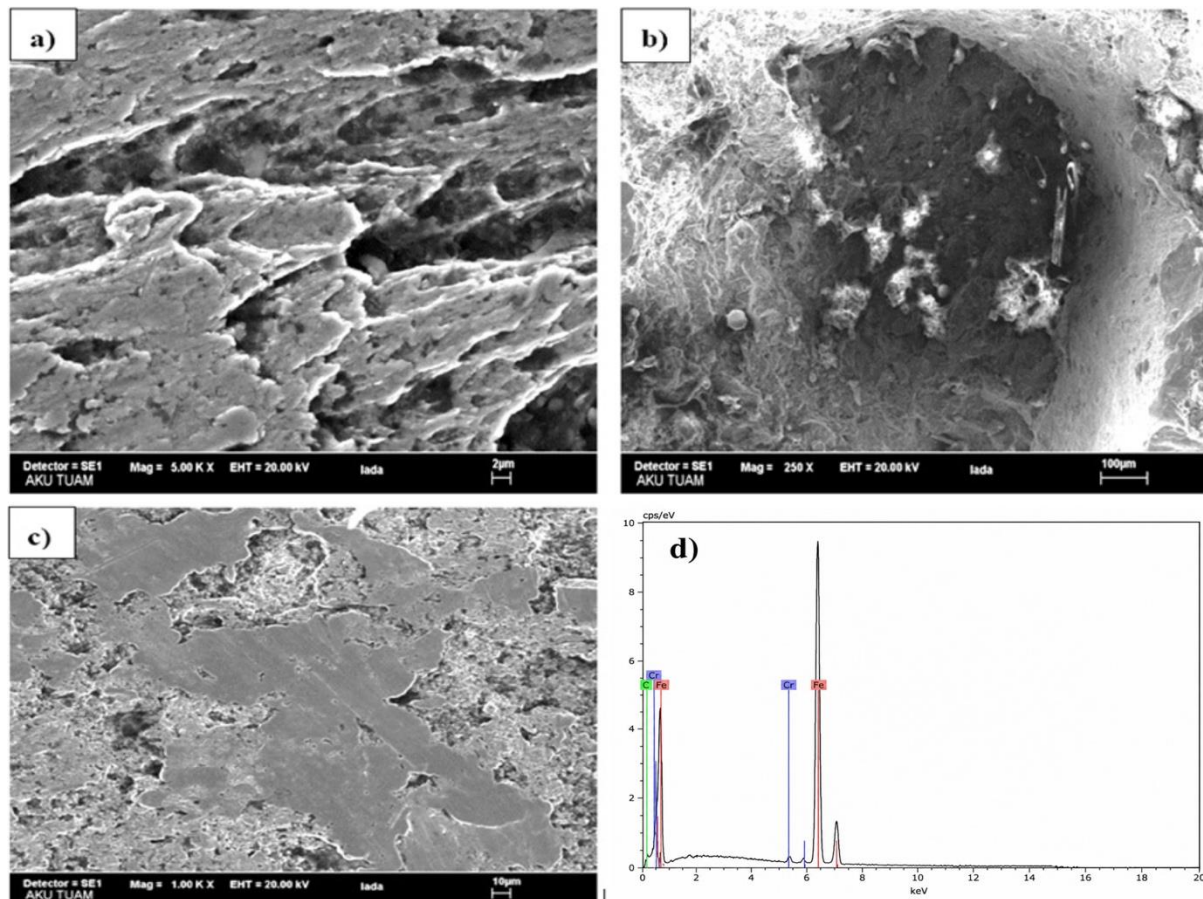
**Figure 8.** SEM and EDX images of Vehicle 2 fracture surface showing crack initiation area, crack propagation region, and final ductile fracture zone

The macroscopically observed "cup-and-cone" fracture form indicates that the material undergoes a certain amount of plastic deformation before rupture and exhibits ductile behavior in the final stage of fracture. In the SEM images [Figure 8a](#) to [Figure 8c](#), especially at high magnifications, micropore (void) formation, microvoid coalescence resulting from the growth and coalescence of these pores due to plastic deformation, fibrous deformation traces, and distinct plastic yield zones are clearly visible. Furthermore, dimple structures characteristic of a ductile fracture mechanism, developing as a result of the growth and coalescence of micro-void formations starting around inclusions and second-phase particles due to plastic deformation, are clearly observed. These findings confirm that

a ductile fracture mechanism is dominant in the final stage of fracture. Although ductile fracture features were observed in the final fracture region of Vehicle 2, these features represent only the last stage of the fracture process. The overall failure mechanism was initiated by fatigue crack formation at a stress concentration region and continued through fatigue crack propagation under cyclic loading conditions. After the fatigue crack reached a critical size, the remaining cross-section could no longer sustain the applied load, resulting in final overload fracture.

[Figure 8](#) shows the SEM and EDX images of Vehicle 2. [Figure 8a](#) reveals fibrous structures indicating that the material absorbs energy during loading and deforms, and that the fracture is not sudden. [Figure 8b](#) shows microscopic depressions and tearing traces progressing from the center to the periphery, supporting the void growth and coalescence mechanism characteristic of ductile fracture. [Figure 8c](#) shows areas of plastic deformation developed perpendicular to the tensile direction and spread over large surfaces. [Figure 8d](#) presents the EDX analysis result for Vehicle 2, showing a homogeneous distribution of the main alloying elements along the fracture surface.

These fracture surface characteristics indicate that the material exhibits high toughness and good deformation capability, and that the spheroidized carbides in the microstructure play a role in delaying crack propagation. This fracture behavior observed in Vehicle 2 is consistent with the homogeneous and ductile microstructure obtained after spherization annealing.
