Investigation and failure analysis of a diesel generator connecting rod

This article reports a failure analysis of a diesel generator set connecting rod type 3516 B that has operated for 79,678 hours. From visual observation, connecting rod cylinder #10 has changed color in the shank area. This phenomenon may represent many cases of generator failure, so an analysis to identify the root cause of the failure is needed for scientific literature. In this case, fault tree analysis, SEM-EDX, chemical composition, and microstructure testing were performed to obtain more comprehensive results. Through fault tree analysis, we found that the connecting rod damage was caused by compression leakage due to wear on the cylinder liner. Scanning Electron Microscopy (SEM) analysis shows that the piston rod material is discolored due to heat, namely the formation of iron oxide. The heat level received by the connecting rod is around 200 °C. We also found a finely formed, easy-to-clean scale where the thickness ranged from 0.00127–0.008 mm. Finally, EDX analysis showed high levels of iron (Fe) and oxygen (O) confirming that the formation of iron-oxide on the metal surface was due to the influence o

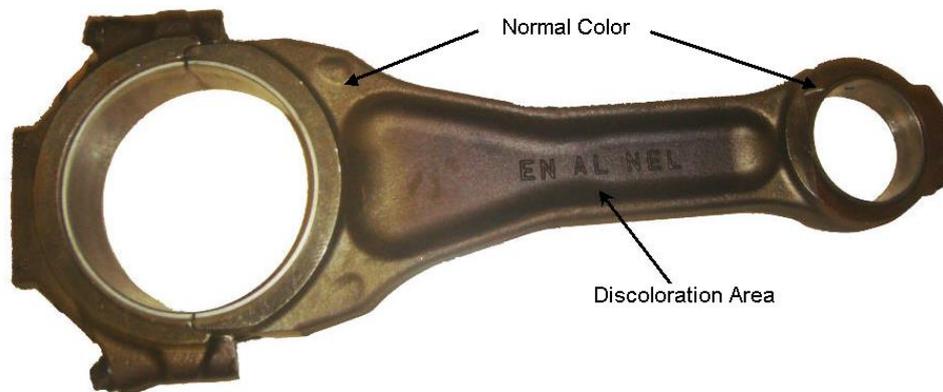
Discoloration of the connecting rod occurs in the shank, from the shape that occurs not completely to all parts of the connecting rod, as shown in Figure 1. In the center of the shank, the color appears darker than the other parts being evaluated. We suspect that there is a compression leak and lubrication failure in the observed cylinder that affects the discoloration of the connecting rod.

Figure 1. Discoloration in the shank area of the connecting rod #10

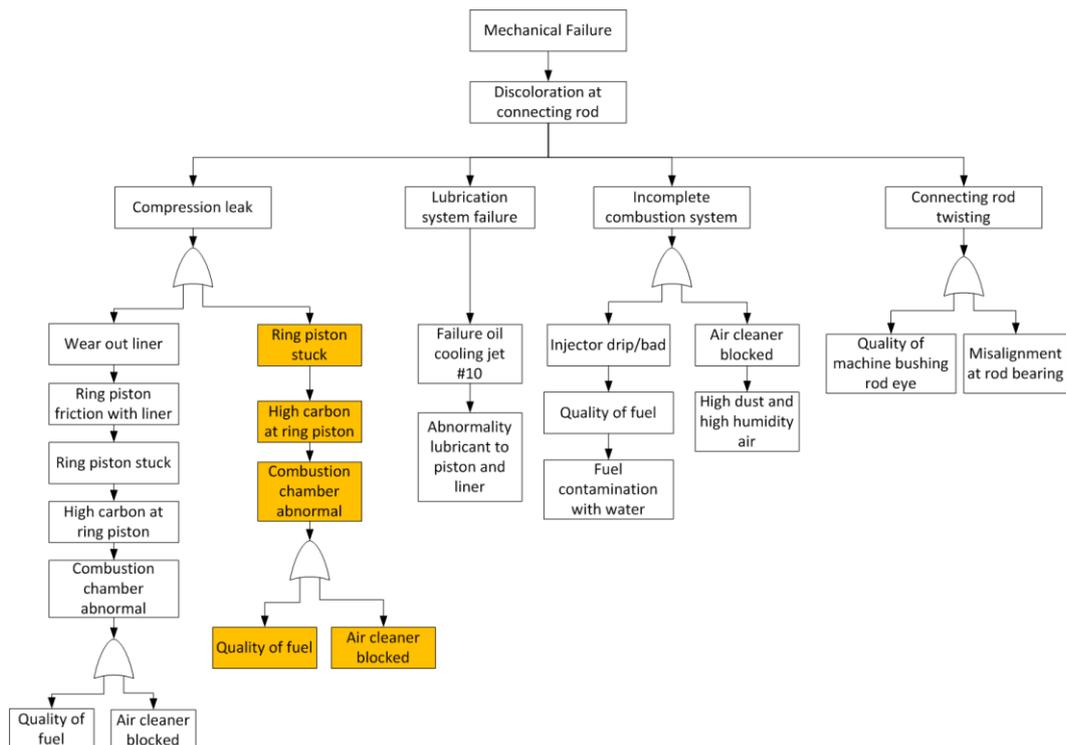
To obtain more detailed results on the cause of heat discoloration on the connecting rod in the shank area, a fault tree analysis (FTA) was implemented as presented in Figure 2. There are four blocks representing compression leak, lubrication system failure, incomplete combustion system, and twisting on connecting rod, respectively. *Compression leak* - Wear on the liner wall causes

Figure 2. Fault Tree Analysis (FTA) on the connecting rod diesel engine 3516 B

compression leakage, where the liner wall is already shiny. In addition, the piston ring was stuck because there is carbon in the piston ring gaps, so it cannot expand. *Lubrication system failure* - Failure of the lubrication system on the oil cooling jet, where the oil cooling jet cannot lubricate the bottom of the piston, so the oil cannot absorb heat and cause heat propagation to the connecting rod. *Incomplete combustion system* - Bad/drip injectors due to fuel quality, where the combustion ratio is not perfect between air and fuel or blocked air filter caused by air quality contaminated with dust or humid air [16]. *Twisting on connecting rod* - The cooling system on the diesel engine has a considerable impact on engine operations, where this cooling system functions to absorb heat generated from the combustion process, as well as friction between metal and metal, if the cooling system is hot, performance of the engine components will decrease [17], [18].

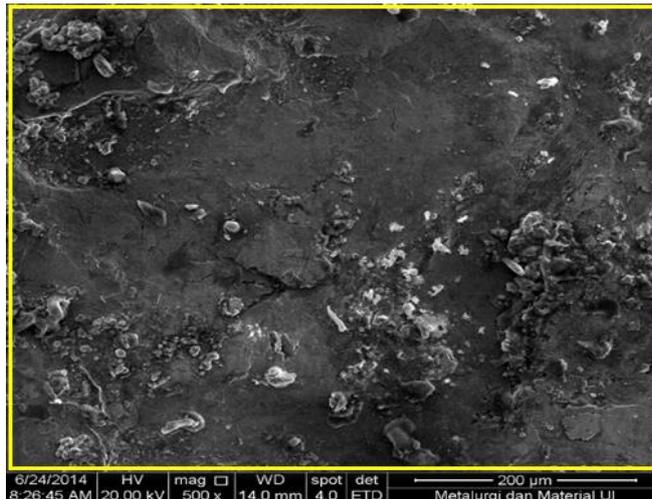
Figure 3.
The results of the SEM material discoloration test with a magnification of 500x

SEM analysis was carried out on a surface that had discoloration. SEM test were intended to determine the cause of discoloration on the connecting rod surface [19]–[21]. The surface of the tested object shows the formation of an iron-oxide structure, namely the formation of morphology. Morphological test results with SEM are shown in **Figure 3**. The area highlighted by the yellow box is the cracked part of the connecting rod under investigation. Then, EDX analysis as presented in **Figure 4** shows the

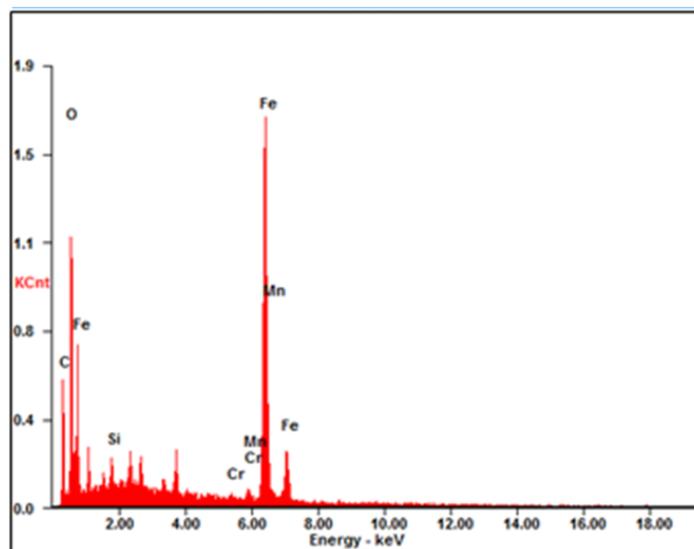
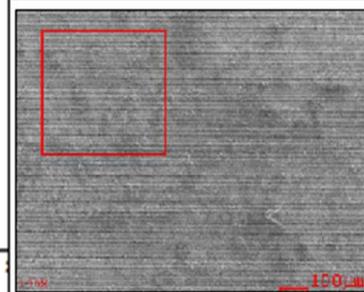
high levels of iron (Fe) and oxygen (O) confirming that the formation of iron-oxide on the metal surface is due to the influence of heat.

Figure 4.
The results of the EDX test of the discolored connecting rod material in the shank

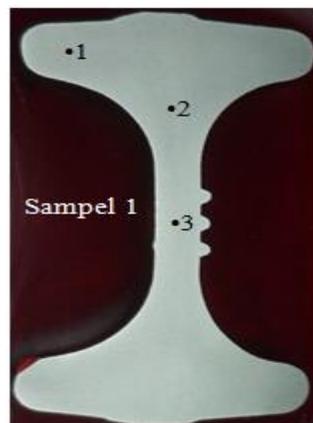
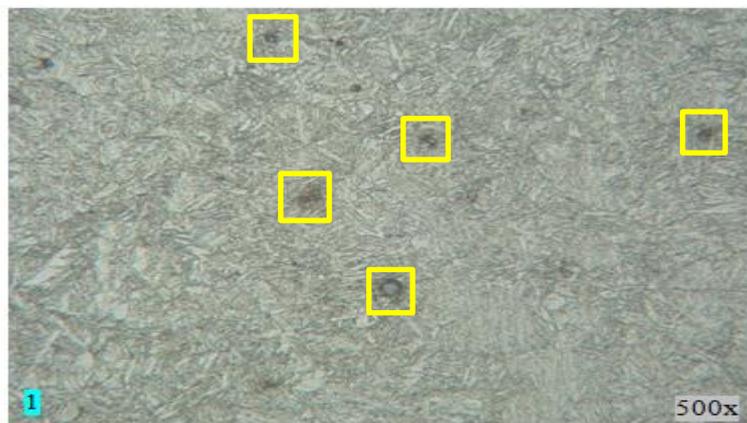
Figure 5.
Microstructure of
location 1 on sample 1

Based on Figure 5 and Figure 6, the structure is composed of tempered martensite which both have sulfide impurities [20]. The impurity sulfide does not affect the color change of the connecting rod and has no relationship with the occurrence of color changes. Then, based on Figure 7, the microstructure is the same as that of sample 1, the microstructure is in the form of tempered martensite with sulfide impurities, and the metal is still in normal condition.

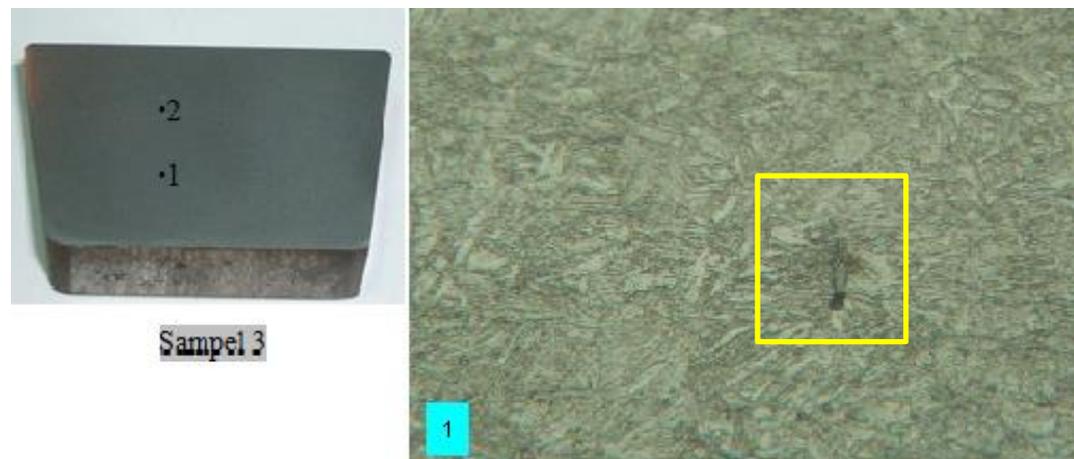
Figure 8.
Location 1 in sample 3

Figure 8 presents the microstructure of sample 1. The temperature increasing that occurs in cylinder liner #10 in the engine has not changed the microstructure of the connecting rod material. From the microstructure test carried out, it was found that the temperature was 200°C, this condition has not been able to change the hardness, strength, and structure of the connecting rod. Based on Pacina et al. [23], the alloy steel will experience temper embrittlement or temper brittleness at temperatures between 300-600 °C where the steel will increase hardness and

decreased ductility. Finally, the type of heat transfer that occurs causes discoloration of the connecting rod due to radiation.
